**Flood Control Project Maintenance
Levee Inspections****LMA District Cover Sheet****Spring 2012 Levee Inspection Results****Reclamation District No. 2095 Paradise Cut**

Levee Inspection Report By Mile - Spring 2012

Reclamation District No. 2095 Paradise Cut

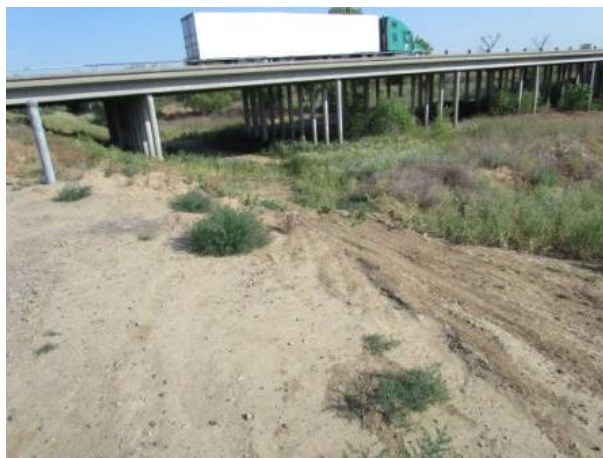
Levee Mile Report Line	4
Start Levee Mile	0.15
End Levee Mile	0.15
Location	Water Side
Category	Earthen Levee
Item	Encroachments

View of vehicle tracks eroding waterside slope.
05/18/2012

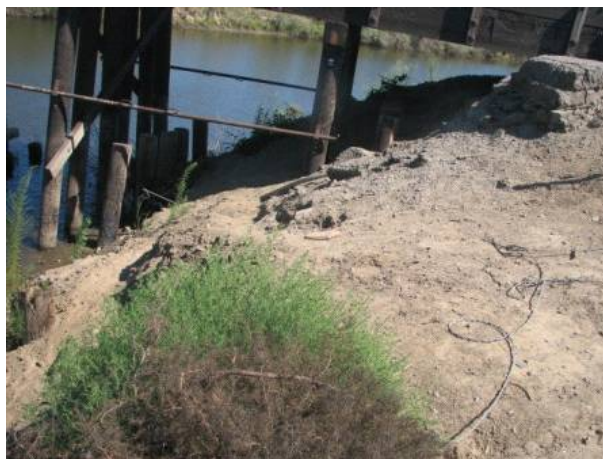
Levee Mile Report Line	8
Start Levee Mile	0.73
End Levee Mile	0.74
Location	Water Side
Category	Supplemental
Item	DWR Erosion Survey

Downstream view of the site.

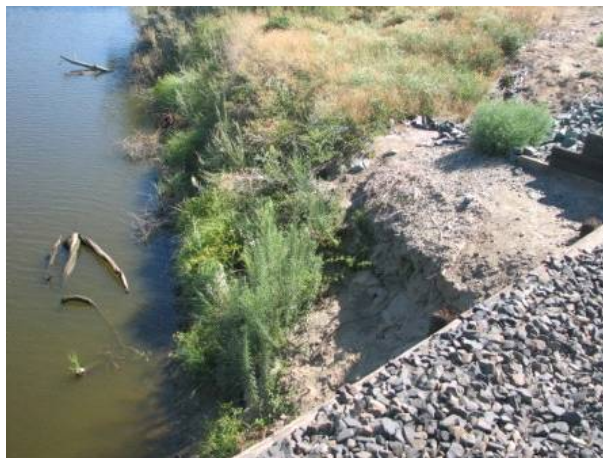
Levee Mile Report Line	8
Start Levee Mile	0.73
End Levee Mile	0.74
Location	Water Side
Category	Supplemental
Item	DWR Erosion Survey

Upstream view of the site looking from the RxR crossing.

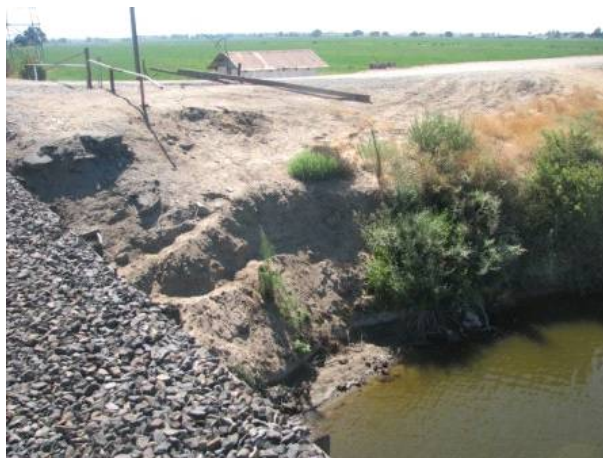
Levee Mile Report Line	8
Start Levee Mile	0.73
End Levee Mile	0.74
Location	Water Side
Category	Supplemental
Item	DWR Erosion Survey

Downstream view of the site from the RxR crossing

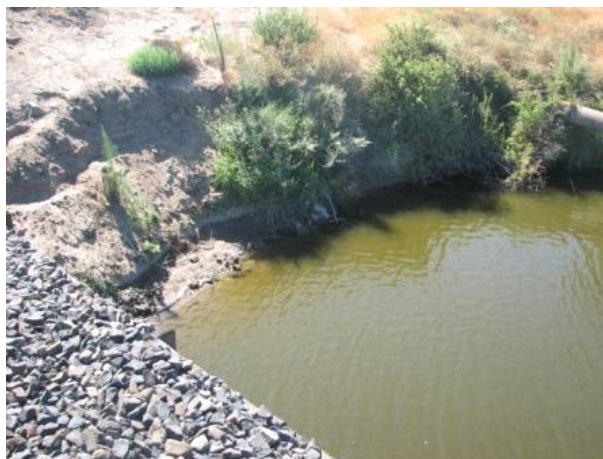
Levee Mile Report Line	8
Start Levee Mile	0.73
End Levee Mile	0.74
Location	Water Side
Category	Supplemental
Item	DWR Erosion Survey

Downstream view of the site.

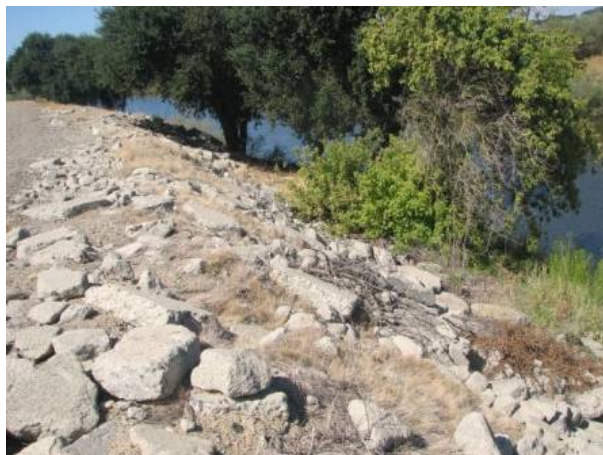
Levee Mile Report Line	9
Start Levee Mile	0.86
End Levee Mile	0.86
Location	Water Side
Category	Supplemental
Item	DWR Erosion Survey

LMR No.	Levee Mile		Category	Item	* Location	** Rating	Action/Comment	GPS Latitude/Longitude		Issue No. Photo
	Start	End						Start	End	
9	0.86	0.86	Supplemental	DWR Erosion Survey	WS	U	Inspector Comments: 09/02/2011: No significant changes observed. 09/22/2010: No significant changes observed. Sloughing of the existing rip rap possibly due to a combination of steep slope and undesirable flood conditions. 08/06/2010: Recommended as local maintenance issue, per CLRO.07/29/2009: No major change observed since last visit; near-vertical slope that has rip rap sloughing; site is recommended as a local maintenance issue, per CLRO CES Evaluation 2008 Report; Site # is the same as RM6.90, LM0.86; previously rated "U". 07/22/2008: Previous erosion site that is partially protected with concrete rubble; erosion scarp is adjacent to the sloughing rip rap. 03/13/2007: Site visited on 03/13/2007. [2011 Site ID: RD2095U01RM6.88]	37.761960 ° -121.318140 °	37.761960 ° -121.318140 °	2 Y

Direct view of the iste.

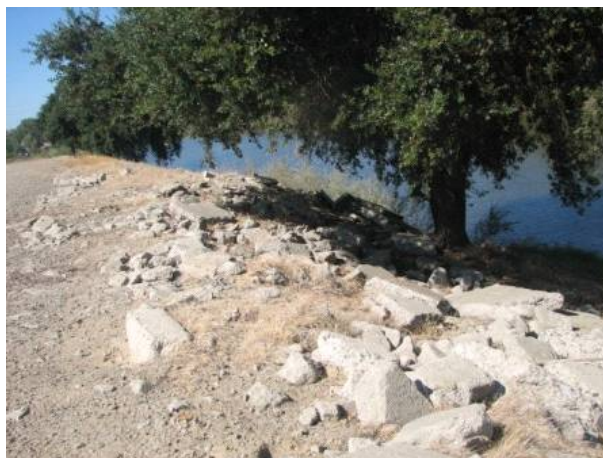
Levee Mile Report Line	9
Start Levee Mile	0.86
End Levee Mile	0.86
Location	Water Side
Category	Supplemental
Item	DWR Erosion Survey

Downstream view of the site.

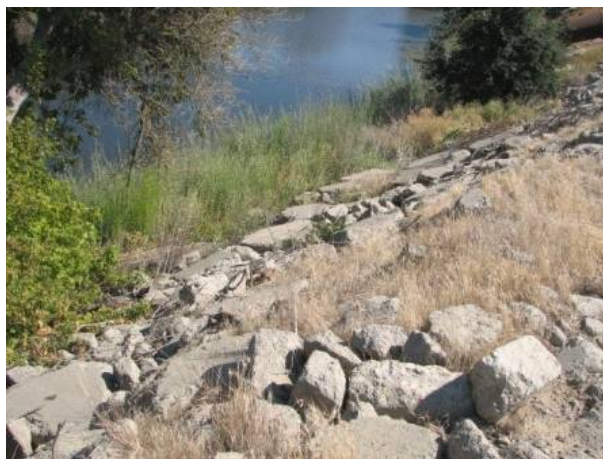
Levee Mile Report Line	9
Start Levee Mile	0.86
End Levee Mile	0.86
Location	Water Side
Category	Supplemental
Item	DWR Erosion Survey

Upwnstream view of the site.

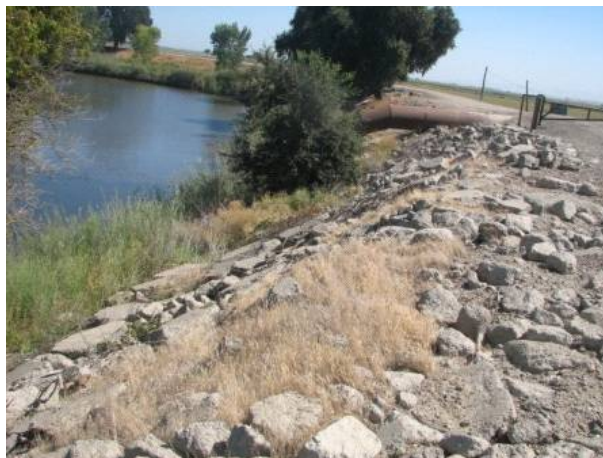
Levee Mile Report Line	9
Start Levee Mile	0.86
End Levee Mile	0.86
Location	Water Side
Category	Supplemental
Item	DWR Erosion Survey

Upstream view of the site from upper slope.

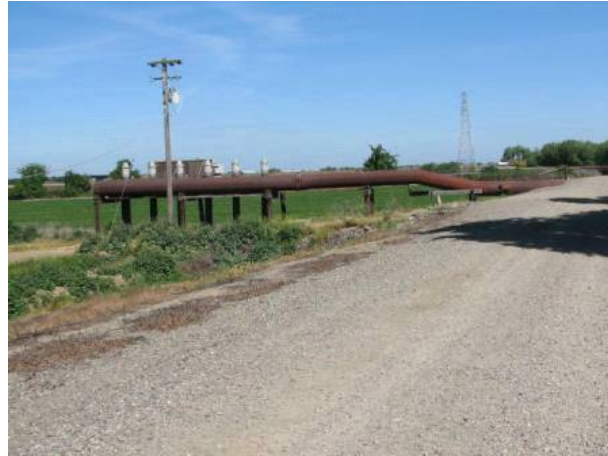
DWR ID: DWR_RD2095_01_s_2012_2										
10	0.88	0.88	Earthen Levee	Encroachments	LS A/W	PI : Pipe	Inspector Comments: Large pump platform for drainage into San Joaquin River. Three pumps. No positive closure devices. Pipe penetrates levee freeboard. No flap gate at outlet.	37.761362 ° -121.318062 °	37.761362 ° -121.318062 °	15 Y
DWR ID: DWR_RD2095_01_s_2012_15										
11	0.88	0.88	Earthen Levee	Encroachments	WSA/W	PI : Pipe	Inspector Comments: Gravity drain through base of levee. Positive closure on waterside hinge point. Flap gate obstructed by debris has been cleared.	37.761337 ° -121.318047 °	37.761337 ° -121.318047 °	16 Y
DWR ID: DWR_RD2095_01_s_2012_16										
12	0.92	0.92	Earthen Levee	Encroachments	LS A/W	PI : Pipe	Inspector Comments: Pipe on south is connected with siphon breaker at hinge point.	37.760792 ° -121.317705 °	37.760792 ° -121.317705 °	18 Y
DWR ID: DWR_RD2095_01_s_2012_18

Levee Mile Report Line	10
Start Levee Mile	0.88
End Levee Mile	0.88
Location	Land Side
Category	Earthen Levee
Item	Encroachments
04/27/2011 Pumps at LM 0.88	
mkhashch_s_20120511_361.jpg

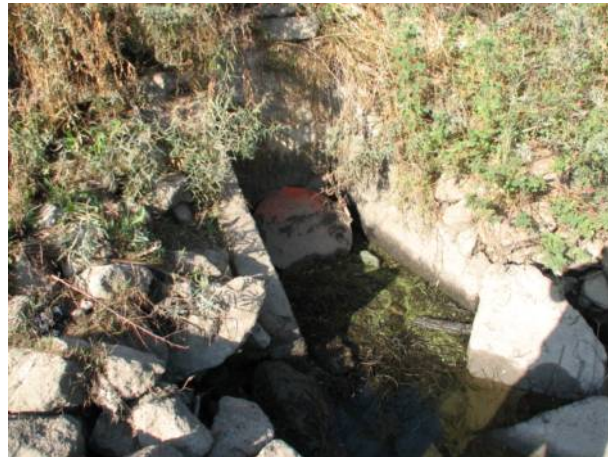
Levee Mile Report Line	11
Start Levee Mile	0.88
End Levee Mile	0.88
Location	Water Side
Category	Earthen Levee
Item	Encroachments
Gravity drainage outlet flapgate blocked by debris.	
mkhashch_s_20120511_362.jpg

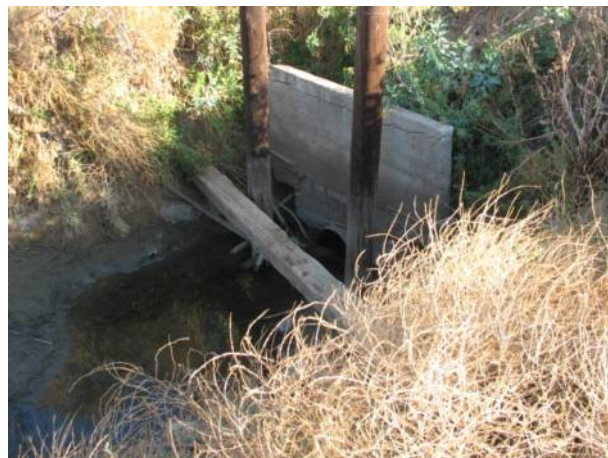
Levee Mile Report Line	11
Start Levee Mile	0.88
End Levee Mile	0.88
Location	Water Side
Category	Earthen Levee
Item	Encroachments
Gravity drain inlet.	
mkhashch_s_20120511_363.jpg

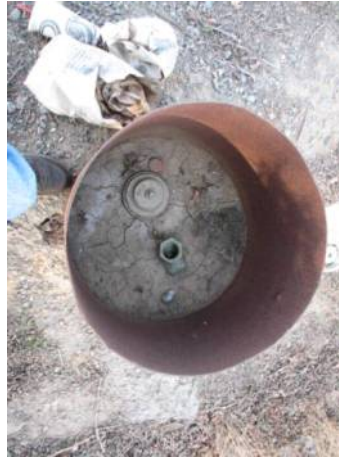
Levee Mile Report Line	12
Start Levee Mile	0.92
End Levee Mile	0.92
Location	Land Side
Category	Earthen Levee
Item	Encroachments
11/01/2011 Siphon breaker at hinge point on waterside.	
mkhashch_s_20120511_364.jpg

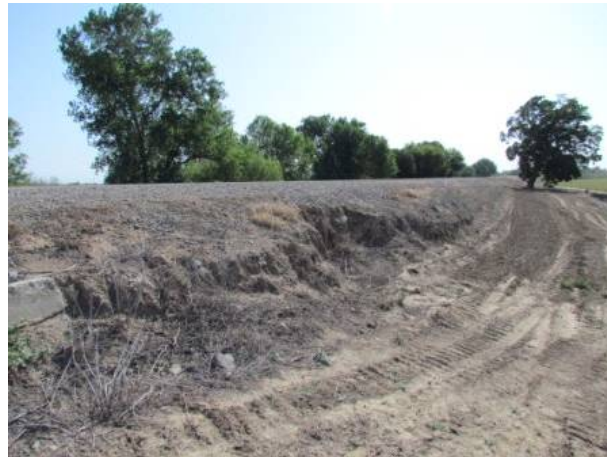
Levee Mile Report Line	13
Start Levee Mile	1.18
End Levee Mile	1.18
Location	Land Side
Category	Earthen Levee
Item	Slope Stability
View of erosion site on landside slope. 05/18/2012	
mkhashch_s_20120518_387.jpg

13	1.18	1.18	Earthen Levee	Slope Stability	LS	M	S1 : Repair slope instability.	37.759802 ° -121.313313 °	37.759802 ° -121.313313 °	33 Y
DWR ID: DWR_RD2095_01_s_2012_33

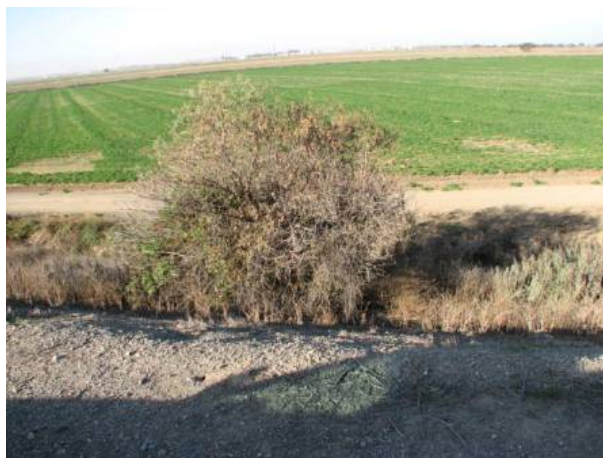
Levee Mile Report Line	1
Start Levee Mile	0.62
End Levee Mile	0.62
Location	Land Side
Category	Earthen Levee
Item	Vegetation

11/01/2011 Elderberry bush at landside toe.

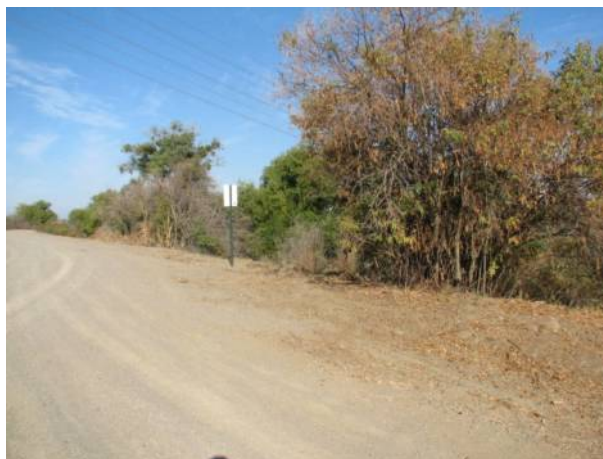
Levee Mile Report Line	5
Start Levee Mile	1.01
End Levee Mile	1.01
Location	Water Side
Category	Earthen Levee
Item	Vegetation

Elderberry blocks visibility of levee slope.

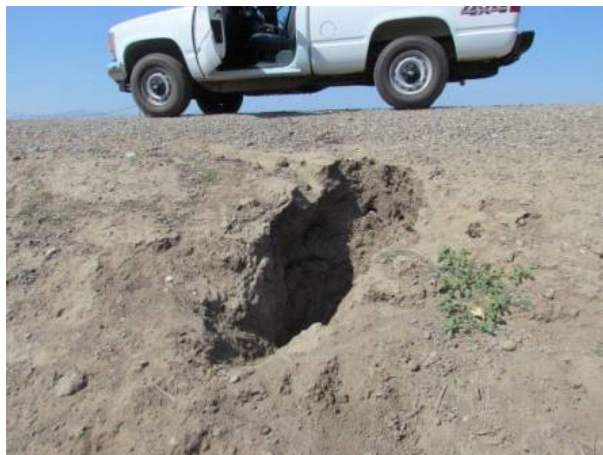
Levee Mile Report Line	8
Start Levee Mile	1.50
End Levee Mile	1.50
Location	Water Side
Category	Earthen Levee
Item	Slope Stability

View of waterside slope caving due to rodent activity. 05/18/2012

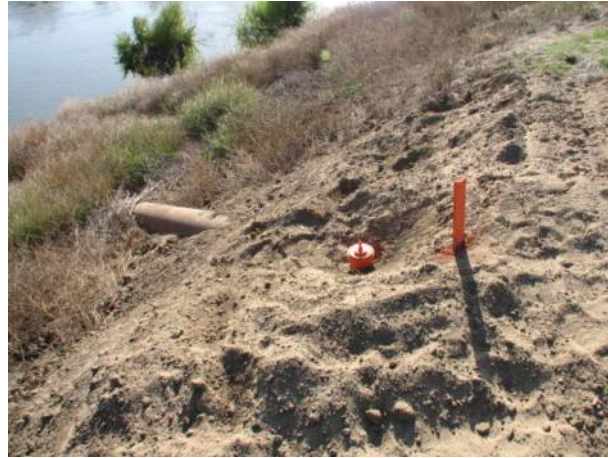
Levee Mile Report Line	10
Start Levee Mile	1.67
End Levee Mile	1.67
Location	Crown
Category	Earthen Levee
Item	Encroachments
11/01/2011 New siphon breaker at waterside hinge point.	
mkhashch_s_20120511_374.jpg

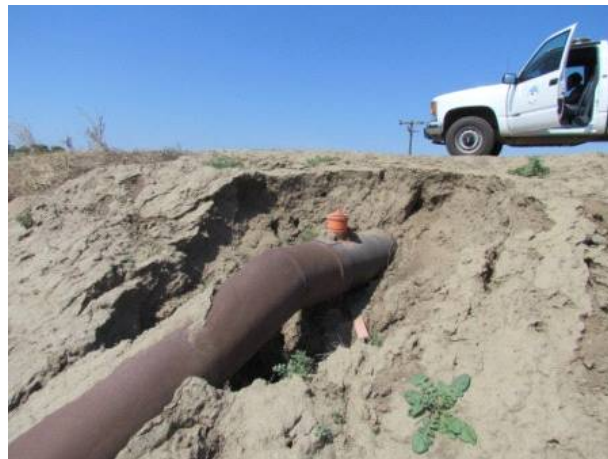
DWR ID: DWR_RD2095_02_s_2012_12									
10	1.67	1.67	Earthen Levee	Encroachments	CRA/W Ma	PI : Pipe Inspector Comments: Discharge pipe into San Joaquin River. Anti-siphon valve present. Pipe penetrates levee freeboard. Fill and compact erosion site.	37.741140 ° -121.296328 °	37.741140 ° -121.296328 °	15 Y
DWR ID: DWR_RD2095_02_s_2012_15									
11	1.77	1.80	Supplemental	DWR Erosion Survey	WS Ma	Inspector Comments: 08/23/2011: No significant changes observed on the site.9/22/2010: No significant changes observed on site. There is moderate vegetation growth on the berm. Despite the erosion occurring on the berm, corrective action should be taken before the issue becomes severe.9/29/2009: Site is immediately downstream of a section of existing rip rap; there is a 20-foot berm remaining; berm will continue to erode unless erosion is mitigated; Site# is the same as RM62.6, LM1.87; recommended for annual assessment, per CES Evaluation 2008 Report2006: Visited 10/20/06 [2011 Site ID:RD2095U02RM60.62]	37.740196 ° -121.297662 °	37.740196 ° -121.297662 °	1 Y

Levee Mile Report Line	10
Start Levee Mile	1.67
End Levee Mile	1.67
Location	Crown
Category	Earthen Levee
Item	Encroachments
View of erosion around pipe on waterside slope. 05/18/2012	
mkhashch_s_20120518_389.jpg

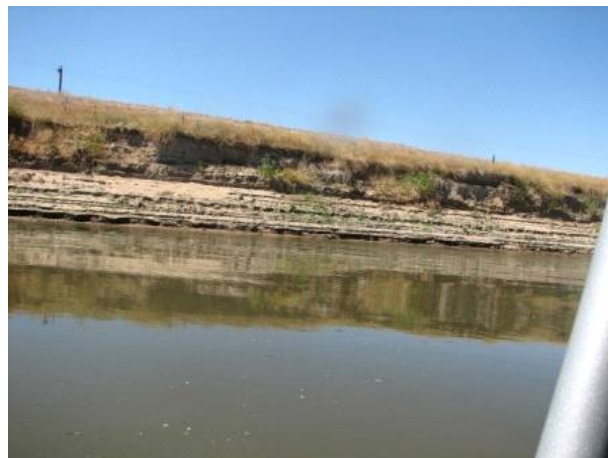
Levee Mile Report Line	11
Start Levee Mile	1.77
End Levee Mile	1.80
Location	Water Side
Category	Supplemental
Item	DWR Erosion Survey
Front view of the site. Note dense vegetation on the berm.	
mkhashch_s_20120511_365.jpg

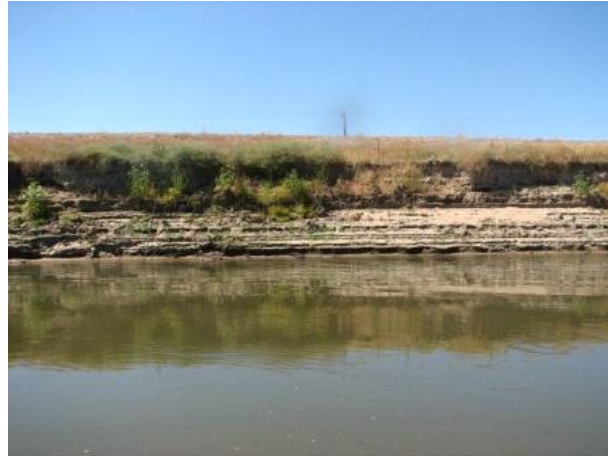
Levee Mile Report Line	11
Start Levee Mile	1.77
End Levee Mile	1.80
Location	Water Side
Category	Supplemental
Item	DWR Erosion Survey

Front view of the site.

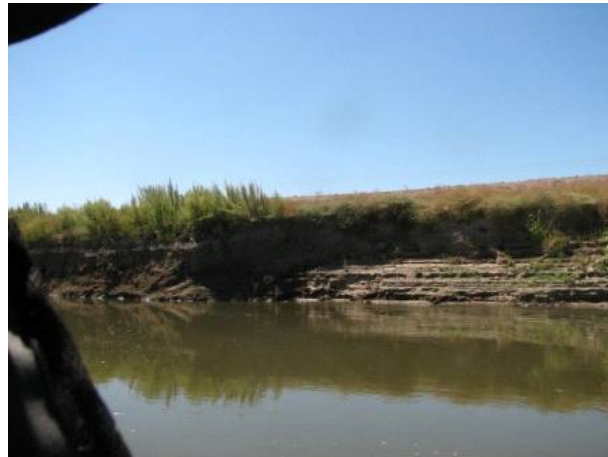
Levee Mile Report Line	11
Start Levee Mile	1.77
End Levee Mile	1.80
Location	Water Side
Category	Supplemental
Item	DWR Erosion Survey

Upstream view of the site.

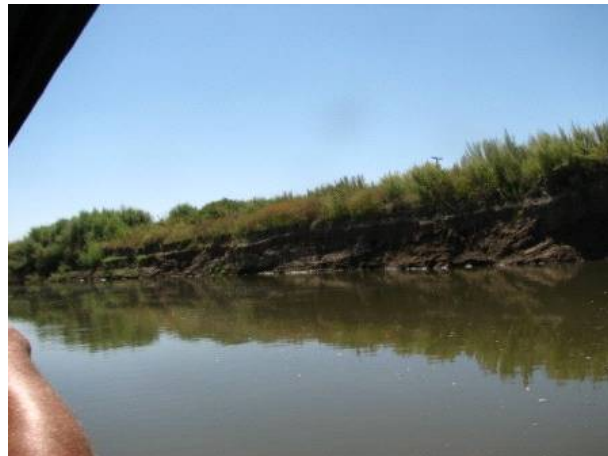
Levee Mile Report Line	11
Start Levee Mile	1.77
End Levee Mile	1.80
Location	Water Side
Category	Supplemental
Item	DWR Erosion Survey

Front view of the site.

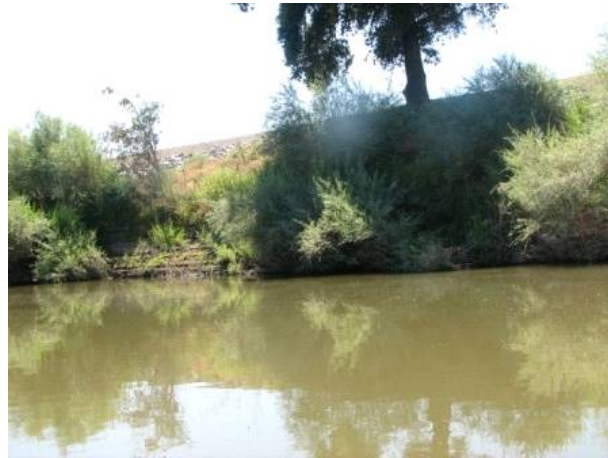
Levee Mile Report Line	12
Start Levee Mile	1.85
End Levee Mile	1.89
Location	Water Side
Category	Supplemental
Item	DWR Erosion Survey

LMR No.	Levee Mile		Category	Item	Location * + Rating	Action/Comment	GPS Latitude/Longitude		Issue No. Photo
	Start	End					Start	End	
12	1.85	1.89	Supplemental	DWR Erosion Survey	WS M Ma	Inspector Comments: 08/23/2011: Dense vegetation makes it difficult to view the possible erosion. No new development was observed on site. 09/23/2010: At the time of the inspection, the erosion site was difficult to view from the levee. Erosion is located on the bank toe, below the existing rip rap. There were no signs of repair on site, nor has the site been reported to be repaired by the district. Images taken from last year indicate that existing rip rap at the bank toe has sloughed exposing the underlaying soils. Weakening of the toe could lead to future bank instability. 08/05/2010: Recommended for annual assessment and monitoring during flood events, per CLRO. 09/29/2009: No major change observed since last visit; sloughing of the rip rap above toe; erosion begins immediately downstream of existing rip rap revetment; roughly 15-foot berm remains; however, it will continue to erode and eventually intrude into the levee profile if left untreated. 10/20/2006: Just upstream of where berm starts to widen. [2011 Site ID: RD2095U02RM60.69]	37.738880 ° -121.298260 °	37.738880 ° -121.298260 °	2 Y

Direct view of the erosion. Note dense vegetation on site

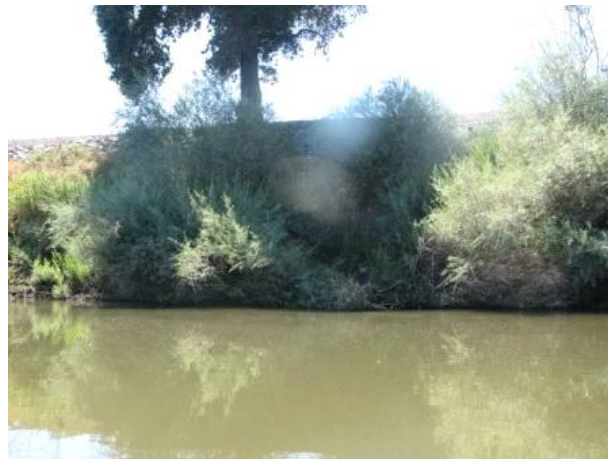
Levee Mile Report Line	12
Start Levee Mile	1.85
End Levee Mile	1.89
Location	Water Side
Category	Supplemental
Item	DWR Erosion Survey

Front view of the erosion.

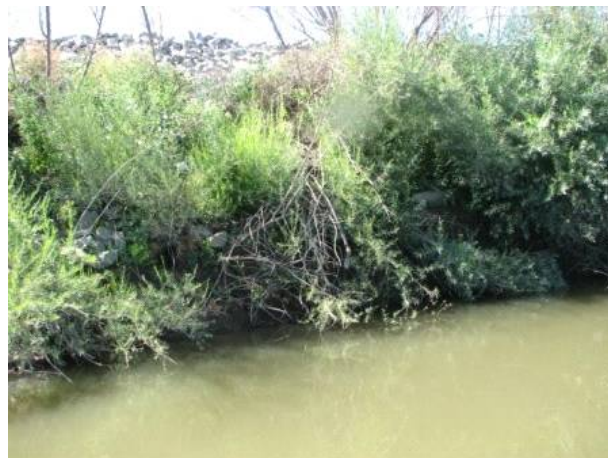
Levee Mile Report Line	12
Start Levee Mile	1.85
End Levee Mile	1.89
Location	Water Side
Category	Supplemental
Item	DWR Erosion Survey

Direct view of the erosion.

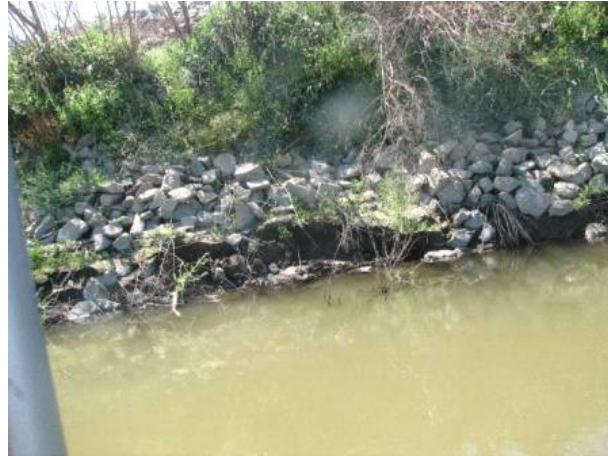
Levee Mile Report Line	12
Start Levee Mile	1.85
End Levee Mile	1.89
Location	Water Side
Category	Supplemental
Item	DWR Erosion Survey

A closer look at the site

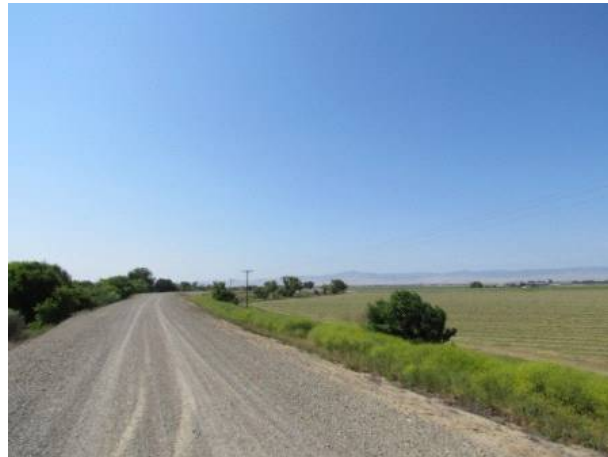
Levee Mile Report Line	14
Start Levee Mile	2.13
End Levee Mile	2.34
Location	Land Side
Category	Earthen Levee
Item	Vegetation

View of tall vegetation obstructing landside slope and toe. 05/18/2012

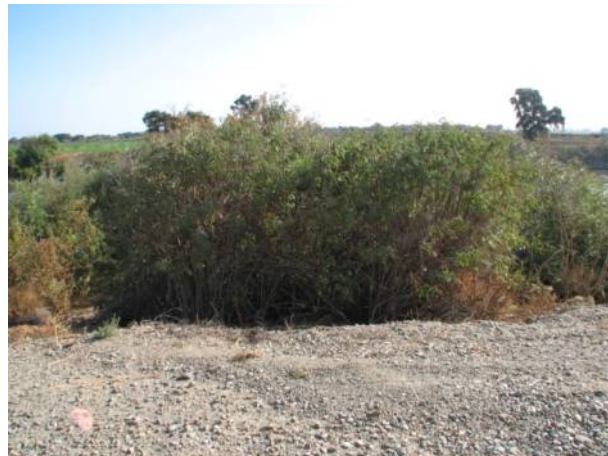
Levee Mile Report Line	15
Start Levee Mile	2.14
End Levee Mile	2.14
Location	Water Side
Category	Earthen Levee
Item	Vegetation

Vegetation on waterside slope obstructs access and visibility.
